### Inspection Report

#### Minerals Regulatory Program

**Mine Name:** Small Fry  
**Operator Name:** Molycorr

**Permit number:** M0370022  
**Inspection Date:** June 14-15, 2006  
**Time:** about 5:00 to 6:30 on the 14<sup>th</sup>;  
about 8:00 to 10:00 on the 15<sup>th</sup>

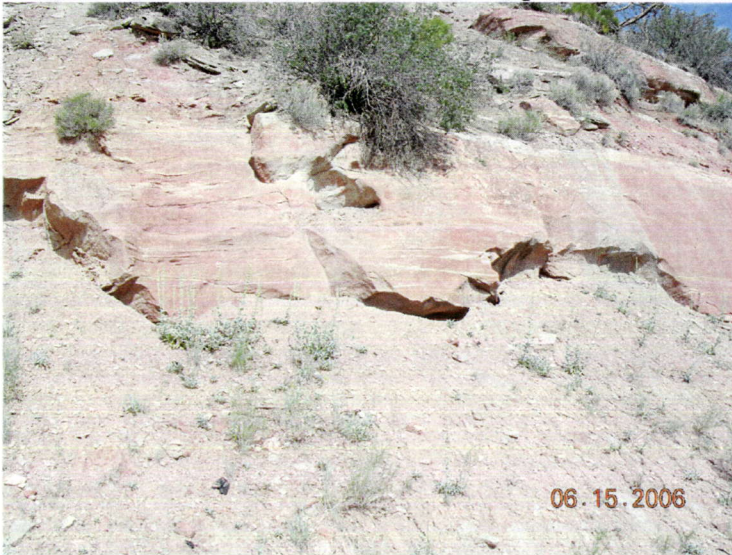
There has been some settling where the portals were backfilled (Photo 1), but I looked very closely and could not see any sign of an opening into the mine workings.

**Photo 1. Backfilled portal area.**

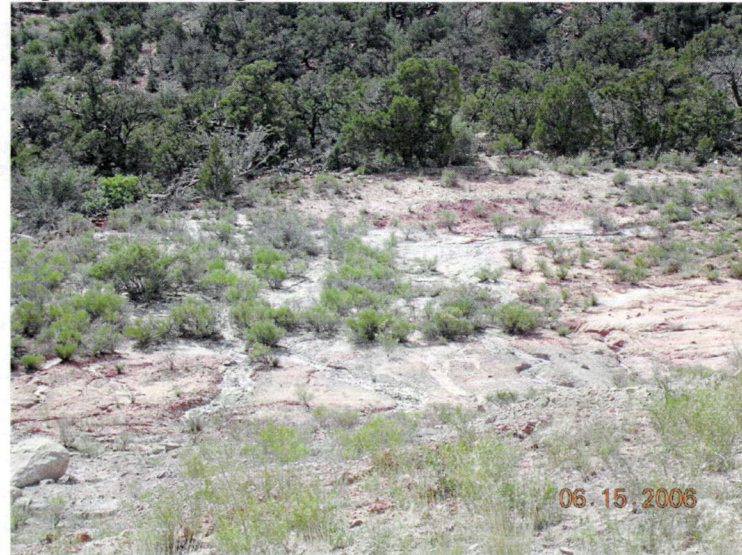
Some parts of the area have very good vegetation cover while others, especially those with more clay, have little or none. As shown in Photos 2 and 3, there has been some erosion on the pad. Toward the south end of the pad in particular, there is a drainage that drops on to the pad which has created a small gully.

**Photo 3. Another view of erosion on the pad.**

There is almost certainly more erosion in the reclaimed areas than in the undisturbed areas which is something of a concern. I do not believe remedial action is necessary because the erosion is not so severe that it is creating large gullies or interfering with grazing or wildlife habitat postmining land uses and because there are no perennial streams nearby. Although some sediment travels outside the disturbed area, most of the sediment has been settling out within the disturbed area.

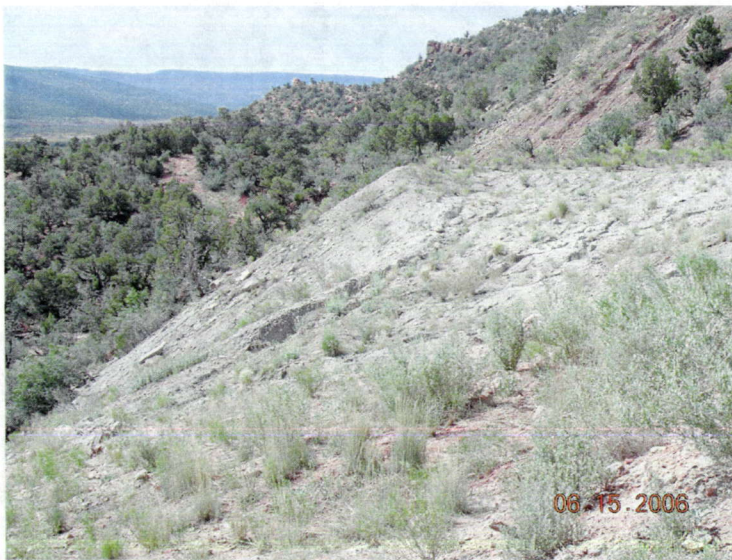
**Photo 2. There has been some erosion, mostly on the steeper slopes in the pad area.**

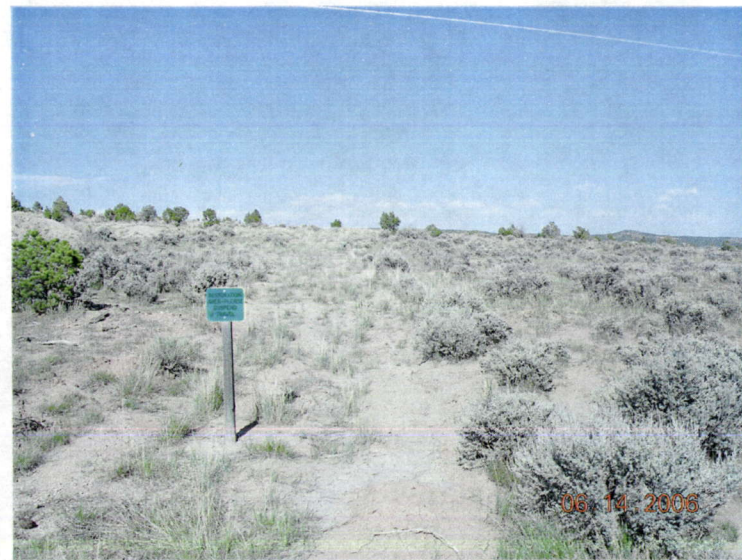
**Photo 4. A reclaimed road on the plateau above the mine.**

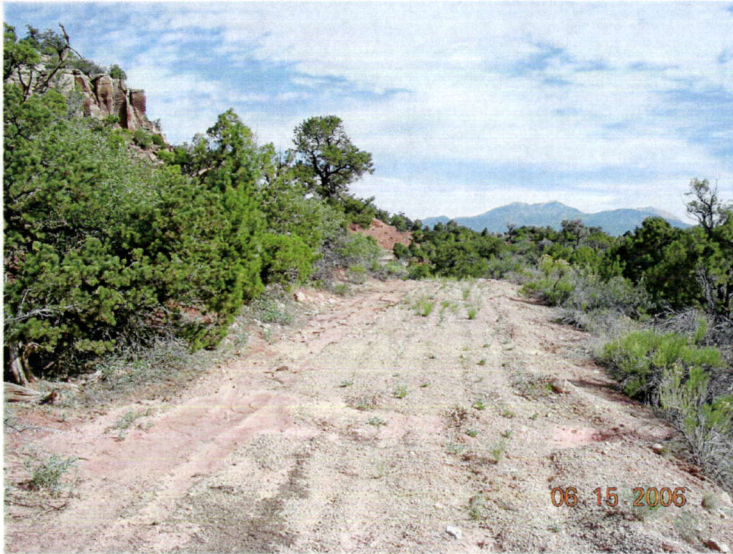
**Photo 5. The mine access road.**

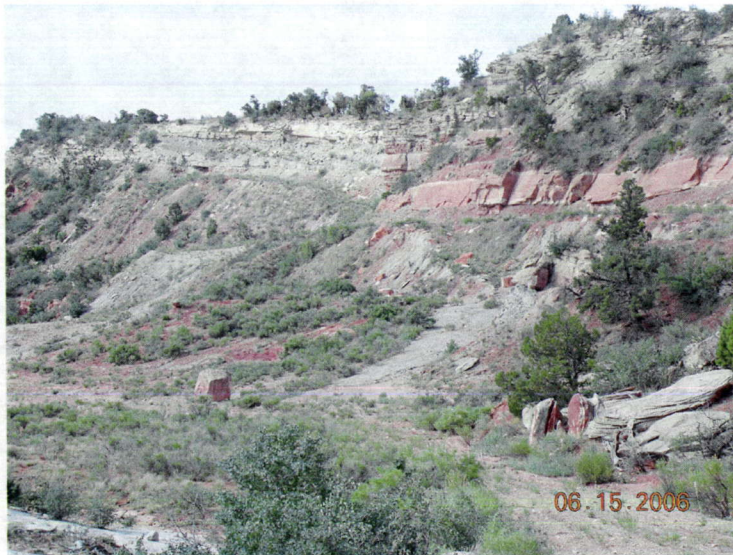
**Photo 6. An overview of the pad.**

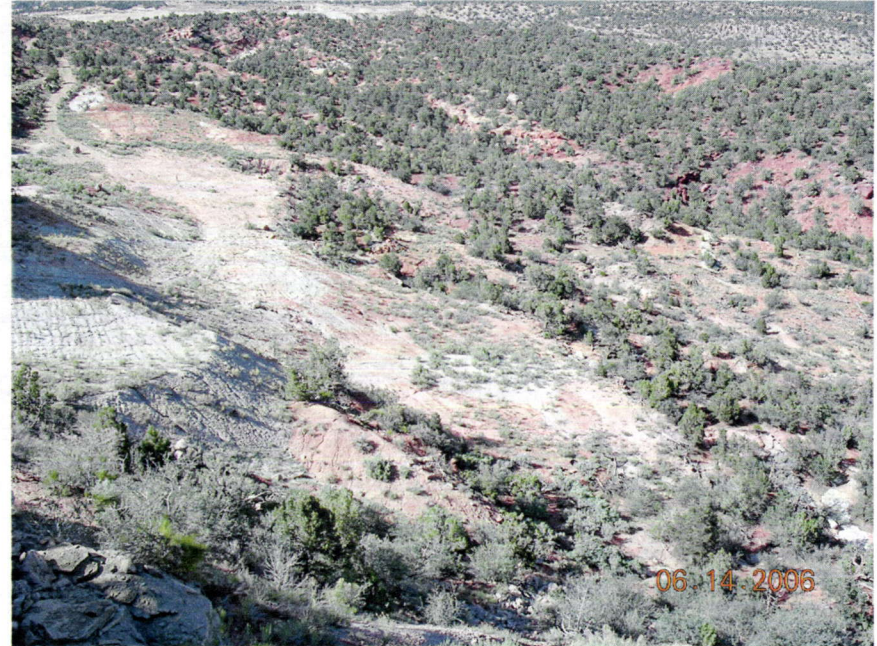
The weighted cover value for the reclaimed area is 14.3 percent. In the undisturbed area, I estimated perennial cover at 17.2 percent.

With the cover in the undisturbed area being 17.2 percent, the revegetation success standard is 12.0 percent. Since cover in the reclaimed area is 14.3 percent, it meets this standard.

**Photo 7. This shows a portion of the pad and some of the undisturbed area below the mine where I measured vegetation cover.**
